# UNDERWATER BRIDGE INSPECTION REPORT

STRUCTURE NO. 27532

CROW RIVER

MINNESOTA DEPARTMENT OF TRANSPORTATION  
UNDERWATER BRIDGE INSPECTION

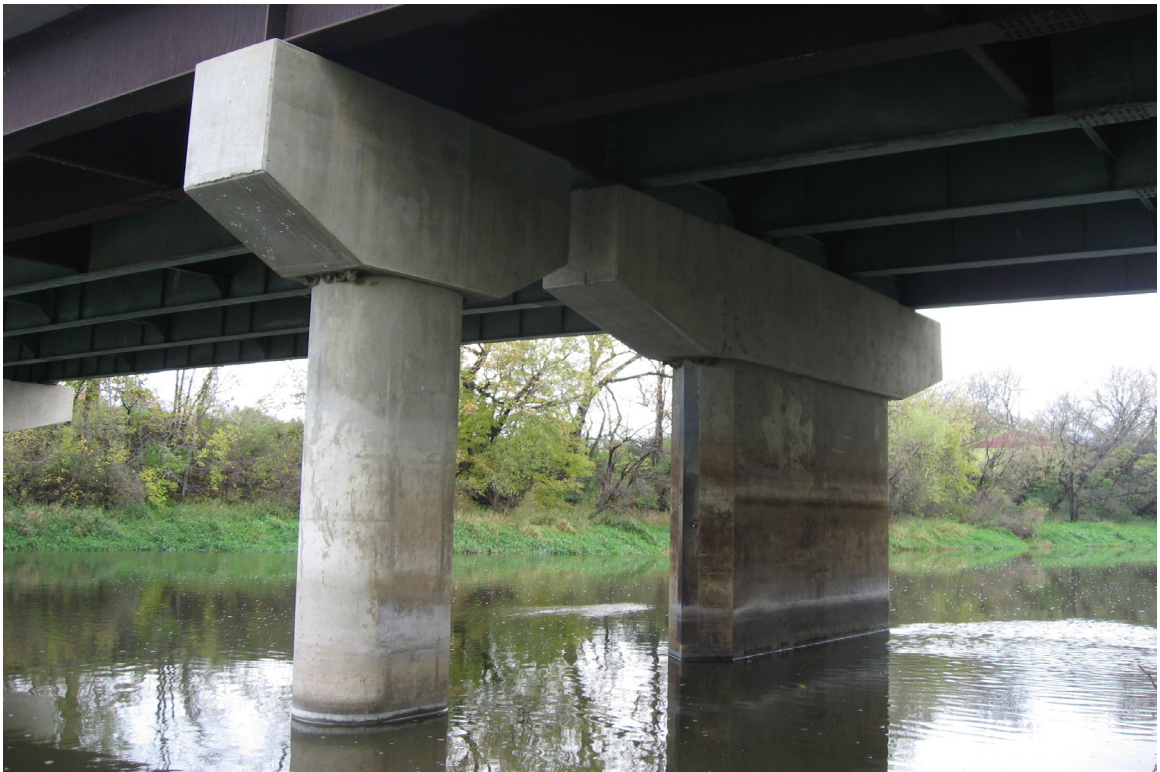
- (A) The footing was exposed along the north face from downstream nose to the upstream nose of Pier 1 with up to 1 (downstream shaft) foot of vertical exposure.
- (B) The downstream portion of both piers exhibited small areas of concrete repair patches approximately 4 feet above the waterline.

Photograph 2. View of Pier 1, Looking Northeast.

- (A) Reinspect the submerged substructure units at the normal maximum recommended (NBIS) interval of five (5) years.

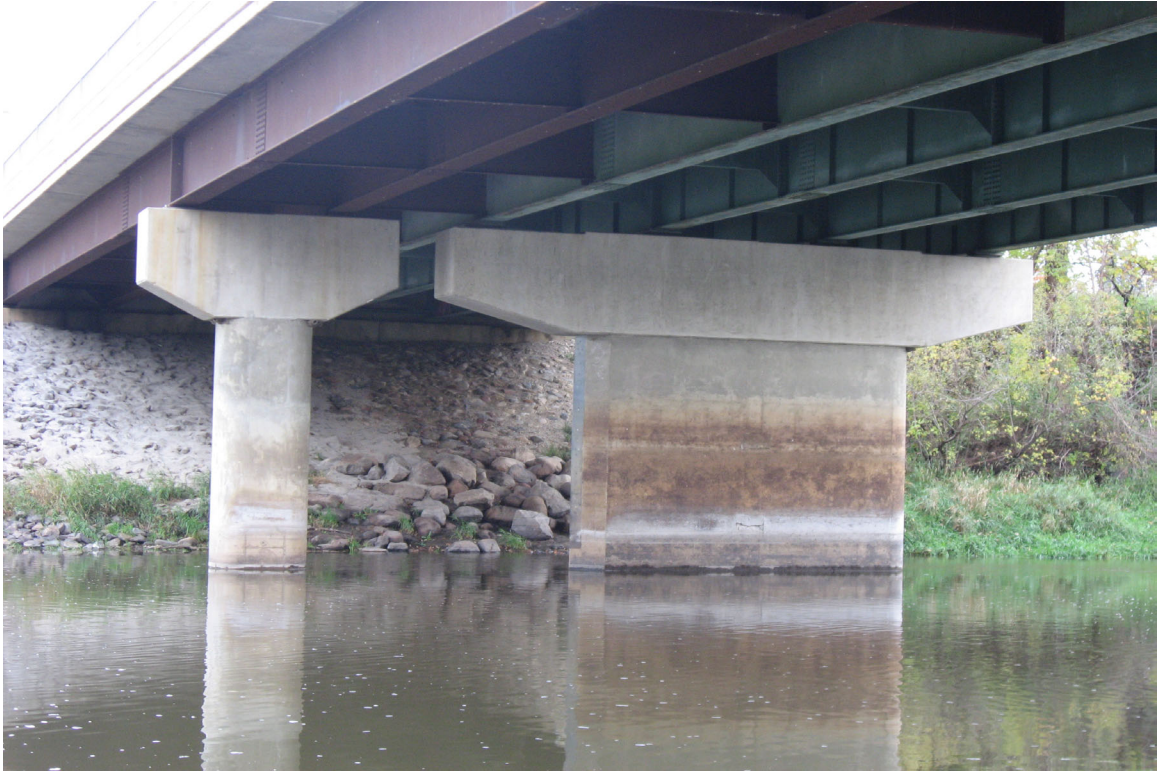
Photograph 3. View of Pier 2, Looking Northeast.

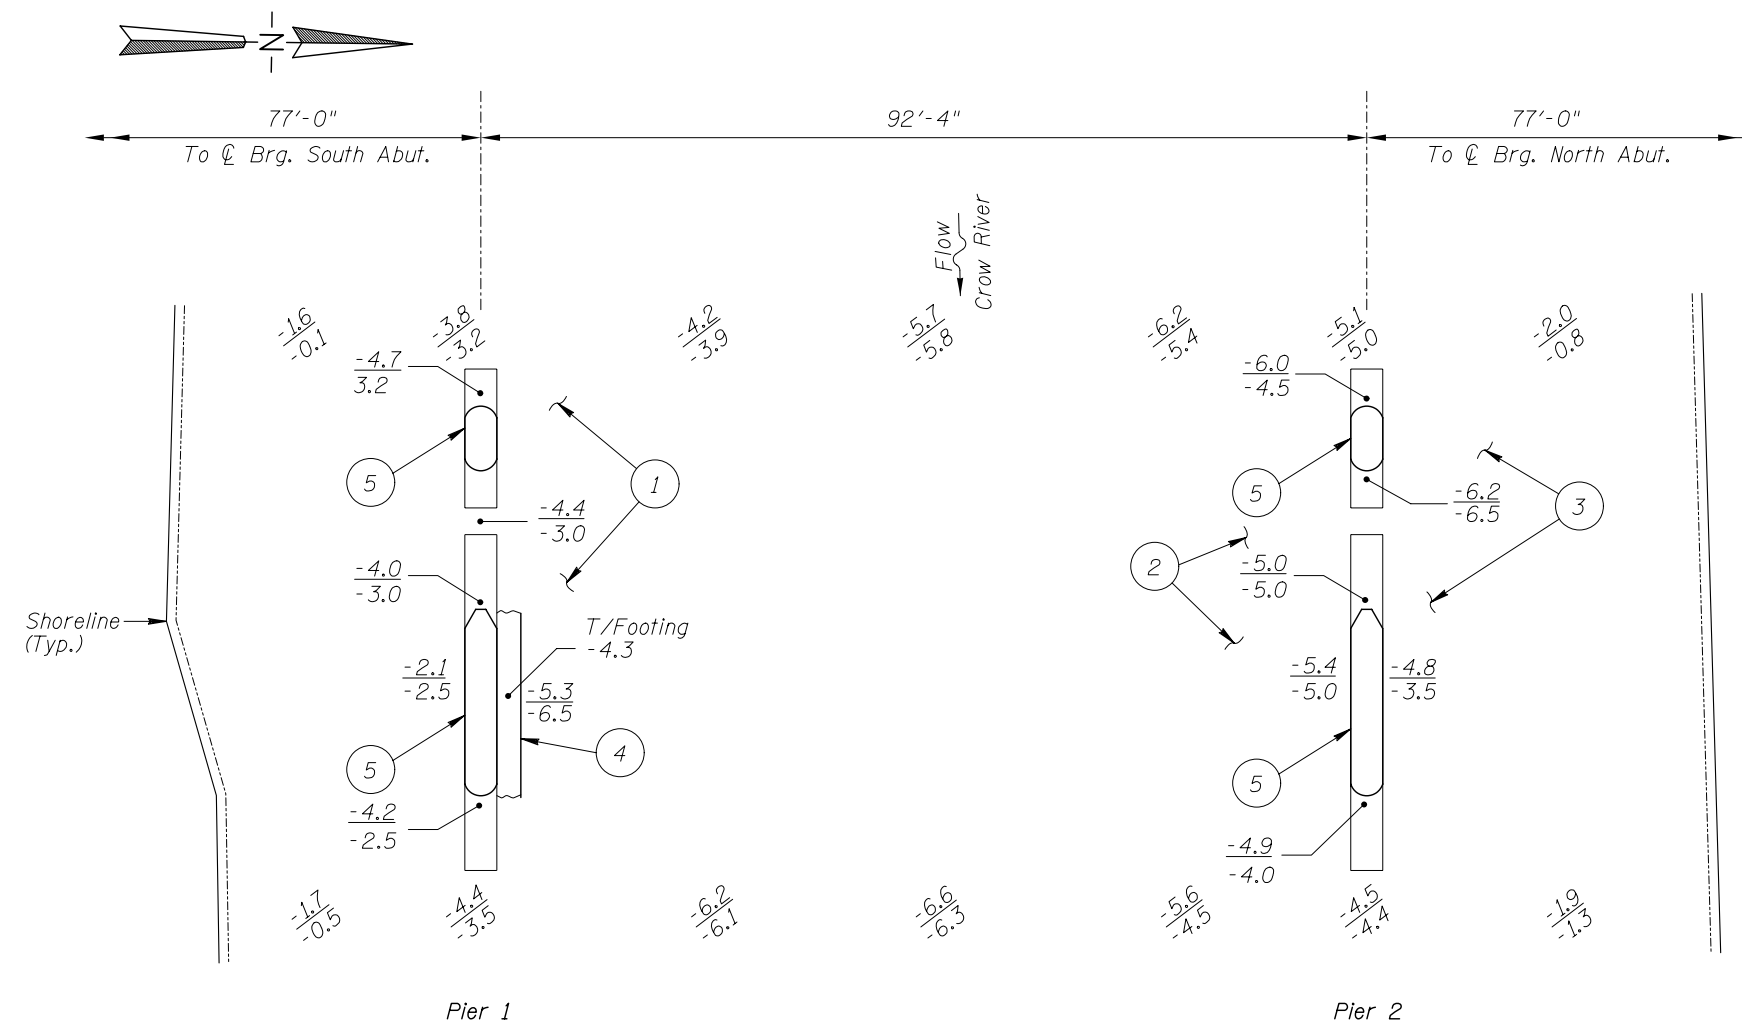
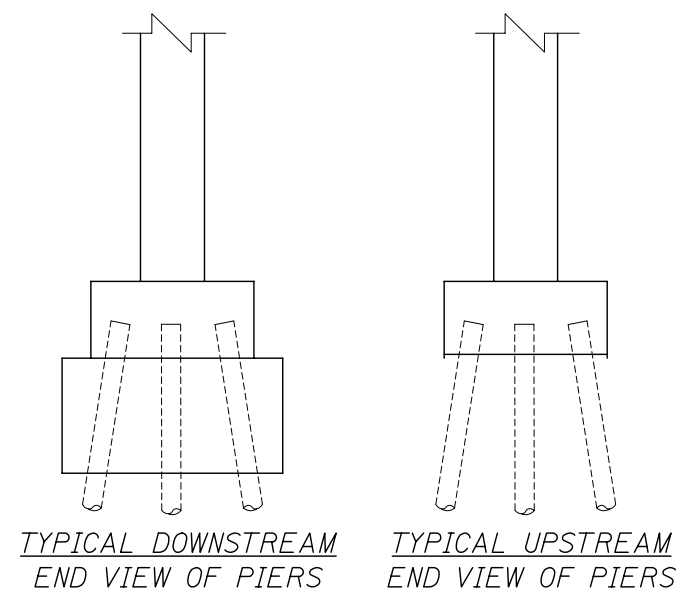
### INSPECTION AND SOUNDING PLAN

- The channel bottom consisted of sandy gravel and 8-inch-diameter riprap with up to 4 inches of probe rod penetration.
- The channel bottom consisted of sandy gravel with up to 4 inches of probe rod penetration.
- The channel bottom consisted of riprap up to 2 feet in diameter with silty sand infilling with up to 3 inches of probe rod penetration.
- The footing was exposed along the north face of the downstream section of Pier 1 with up to 1 foot of vertical face exposure.
- Overall, the concrete was in smooth and sound condition with random minor areas of poor consolidation with penetrations of up to 1/8 inch.
